**ASBESTOS MANAGEMENT PLAN
AHERA THREE YEAR REINSPECTION**

**CHANDLER TRIPP SCHOOL
780 THORNTON WAY
SAN JOSE, CALIFORNIA**

April 13, 2005

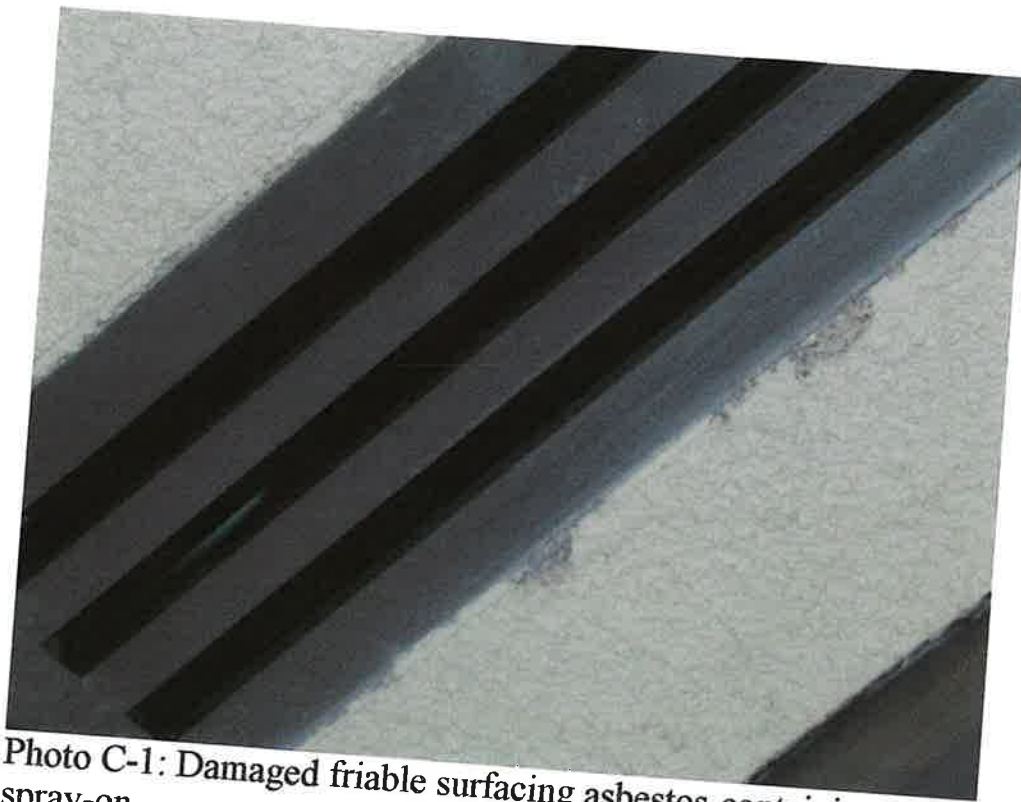
Photo C-1: Damaged friable surfacing asbestos-containing ceiling acoustic spray-on.

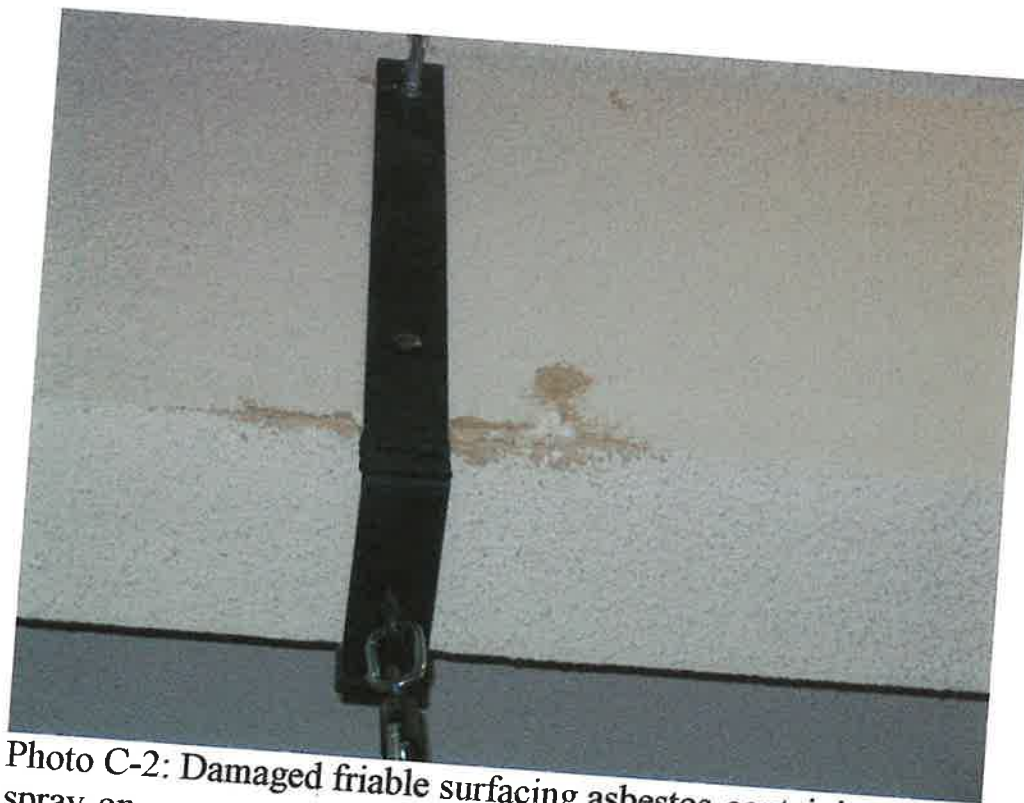
Photo C-2: Damaged friable surfacing asbestos-containing ceiling acoustic spray-on.

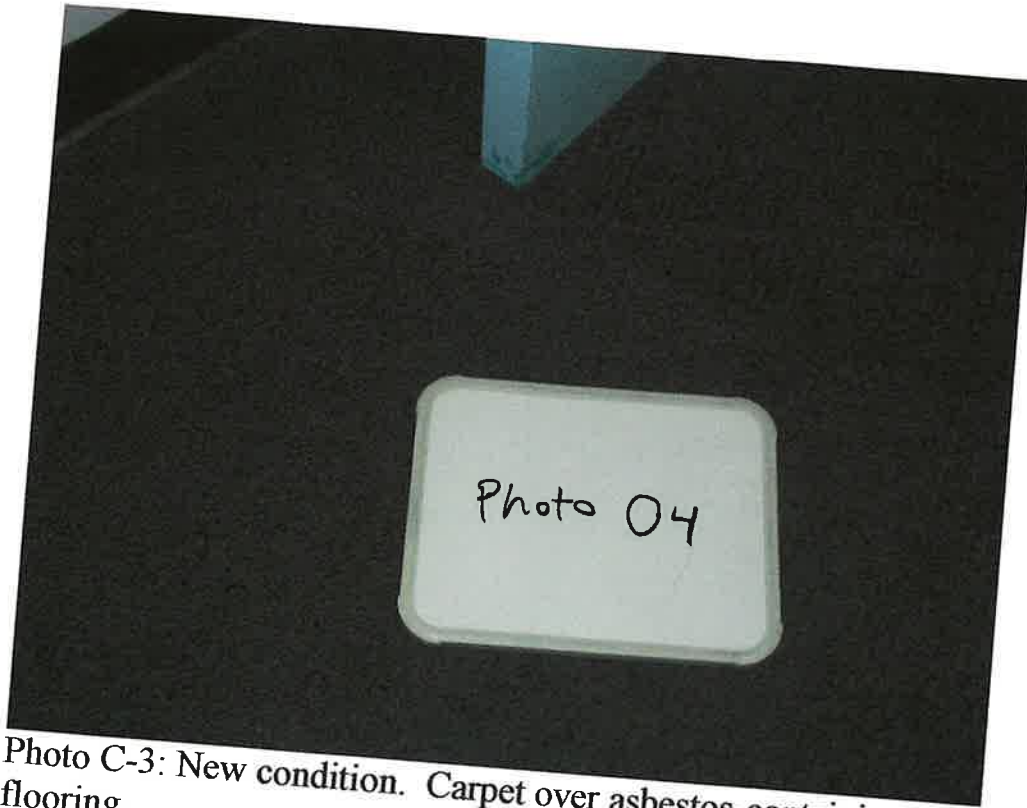
Photo C-3: New condition. Carpet over asbestos-containing vinyl sheet flooring.

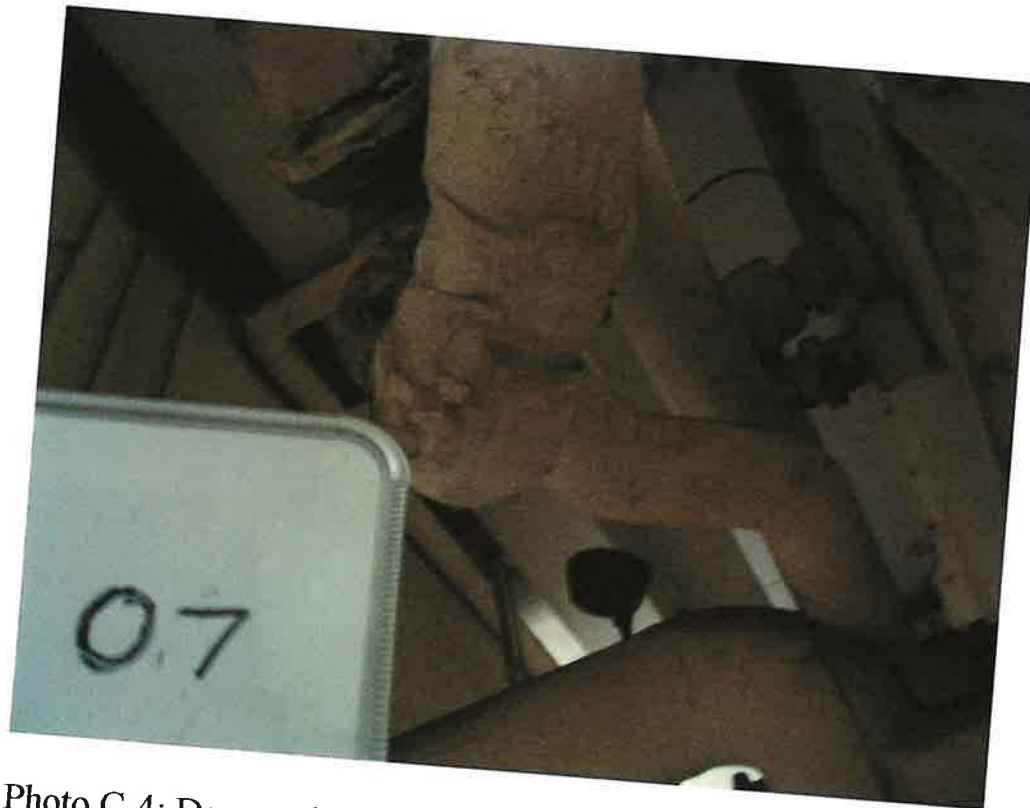
Photo C-4: Damaged friable thermal system insulation asbestos-containing pipe elbow.

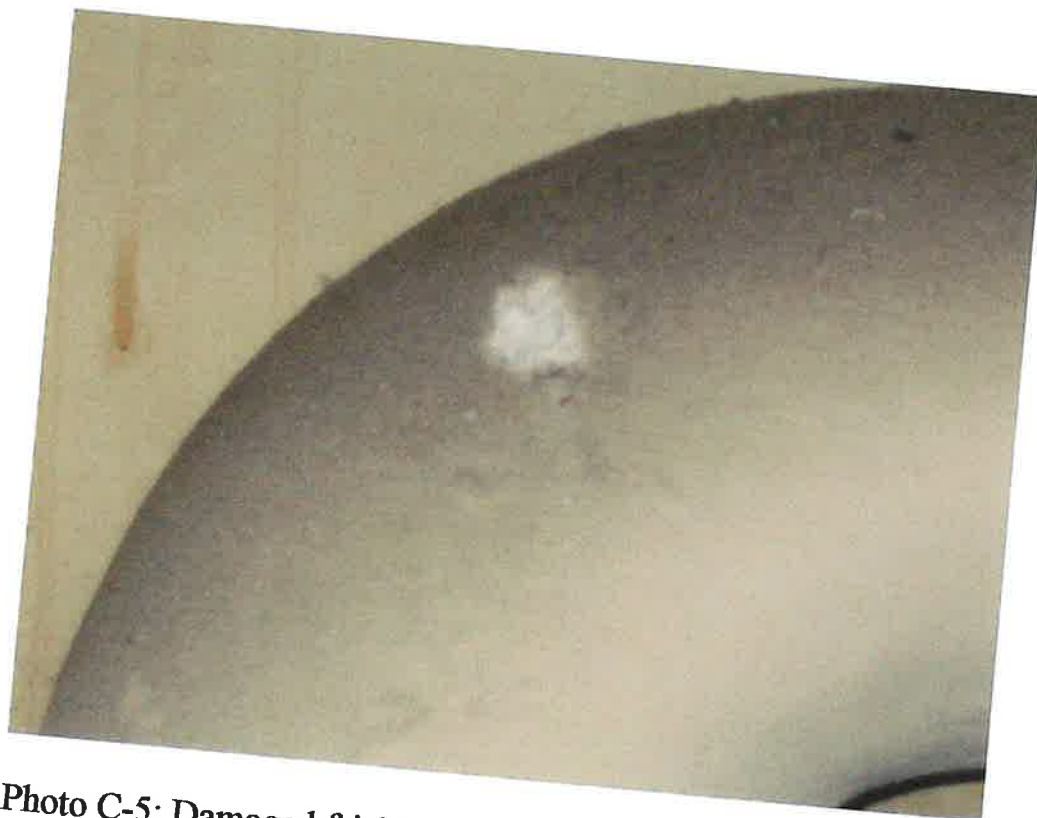
Photo C-5: Damaged friable thermal system insulation asbestos containing pipe elbow.
